On June 15<sup>th</sup> 2010, a Single Engine Air Tanker (SEAT), call sign T-xxx, was returning from the Duckett Fire after dropping fire retardant for Division Bravo. The pilot stated that approximately 12 miles out from the Fremont County Airport (1V6) he monitored the airport's Automated Weather Observation System (AWOS) to receive the current weather information.

### **Corrective Action**

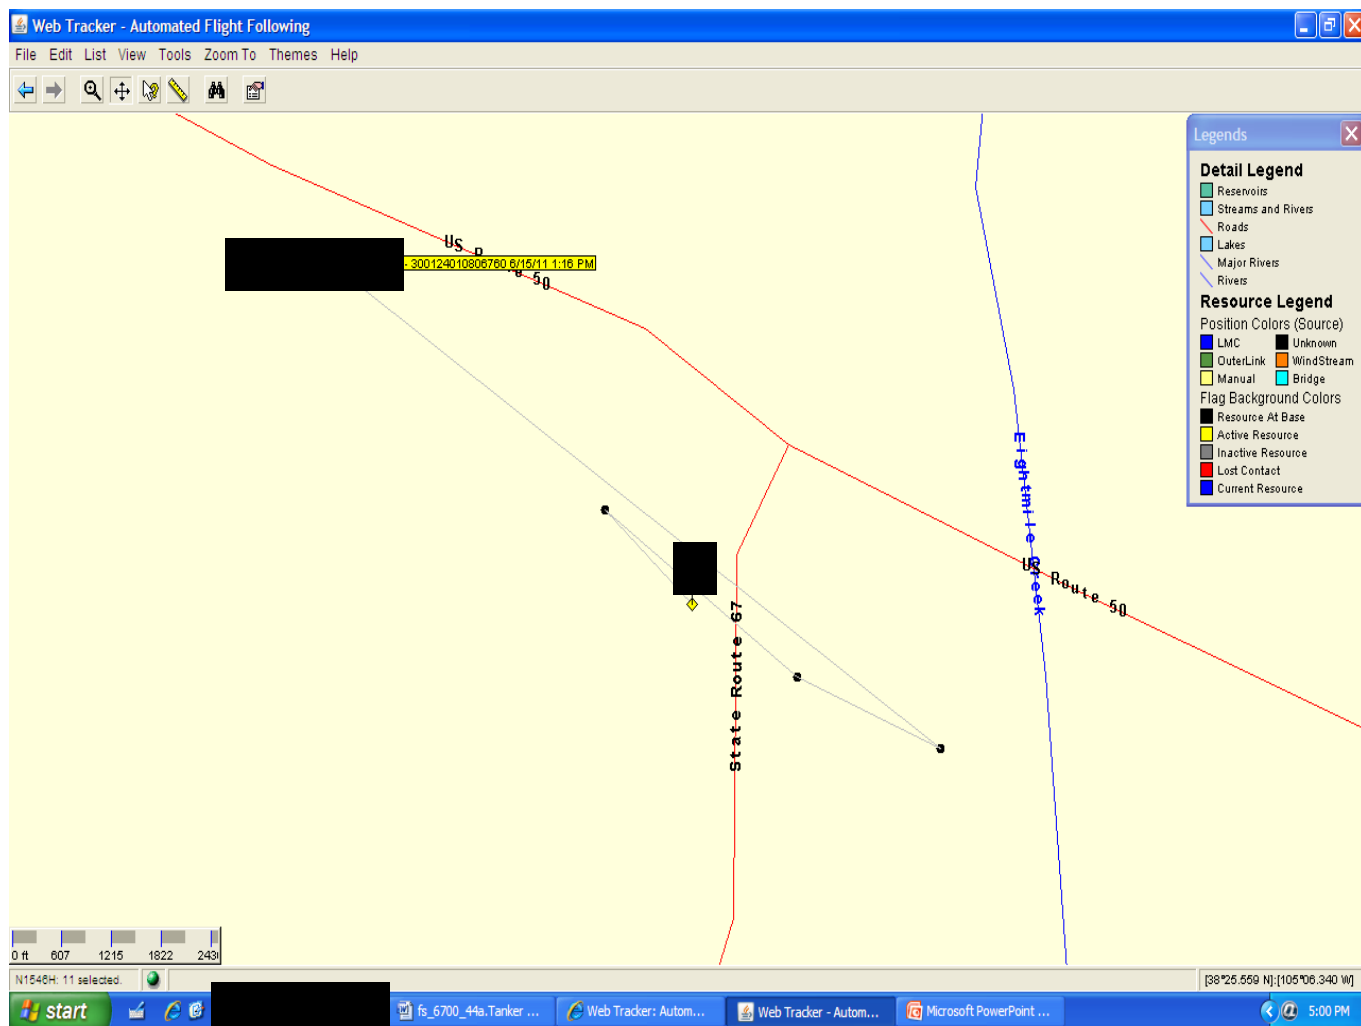
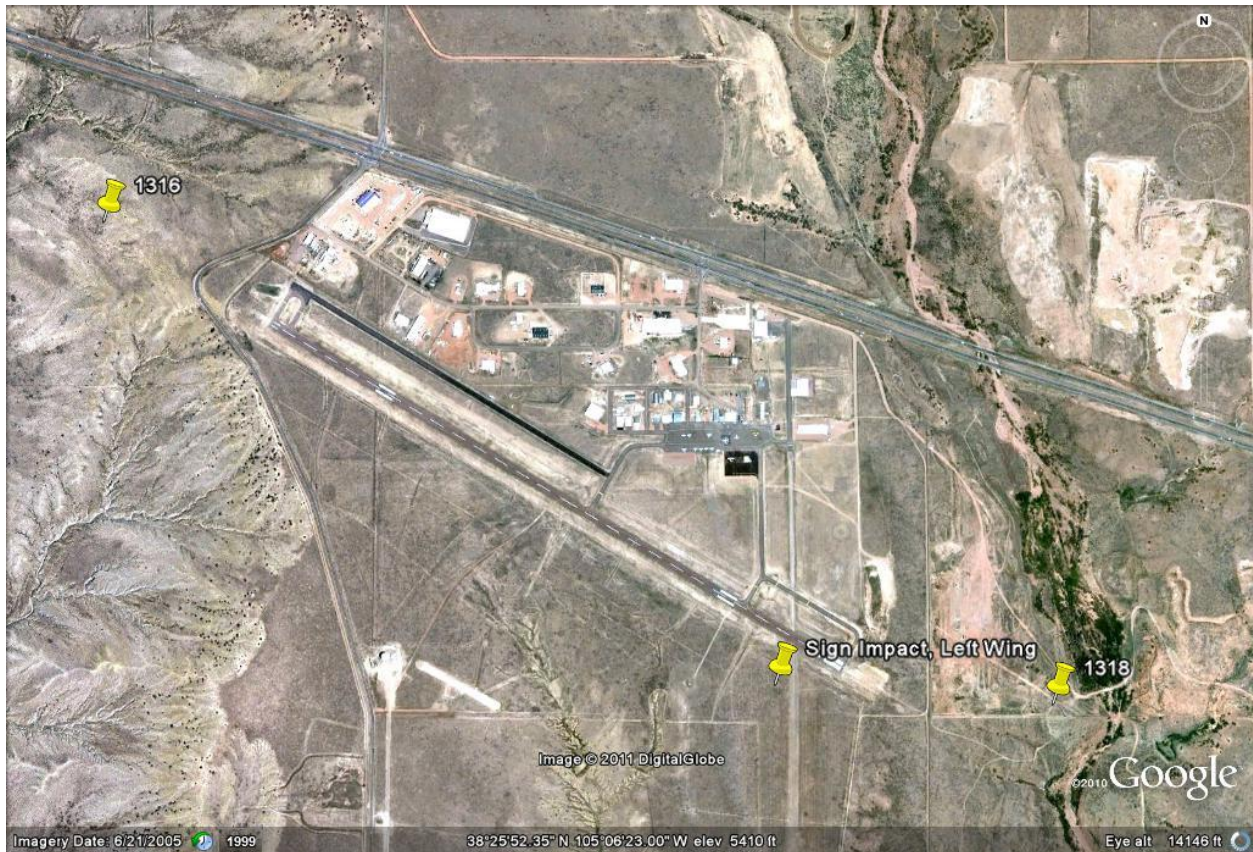
Weather observations recorded at the airport (SAI AWOS/ASOS) during the 10 minute period (1:16 – 1:26 pm) in which the aircraft attempted to land showed average wind speeds 14-21 mph and gusts of 40 mph. Winds were variable as recorded at time intervals 1:16 pm = 150 v 210, 1:17-1:18 pm = 190 v 280 and 1:25 pm = 210 v 270 degrees. Visibility was 10 miles and clear.

(SAI AWOS/ASOS) recordings prior to 1:16 pm and after 1:27 pm show consistent and steady winds 6-18 mph and with gusts 15-23 mph.
